Sample Community Association

Level 1 Reserve Study

Report Period - 1/1/2024 to 12/31/2024

Executive Summary - Sample Community Association - ID # 10014

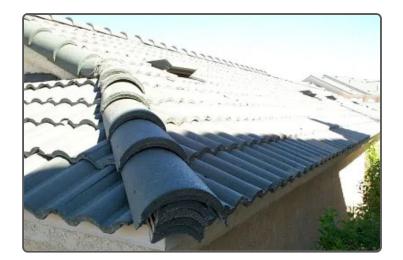
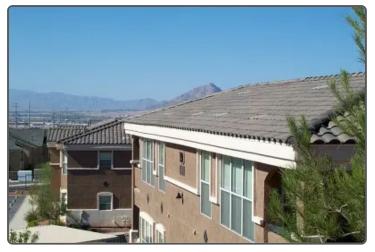
Comp # 106 Pitched Roof - Tile - Replace

No problems noted or reported. Tile roofs have a typical life expectancy of approximately 25 to 30 years before underlayment deterioration causes significant leaks. Inspect roofs regularly and make repairs as necessary as an operating expense to ensure full life. Remaining life based on current age.

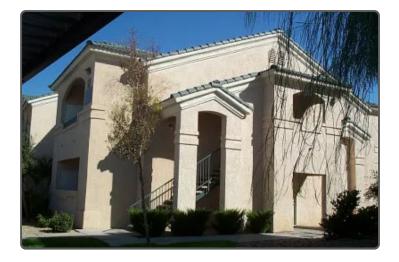
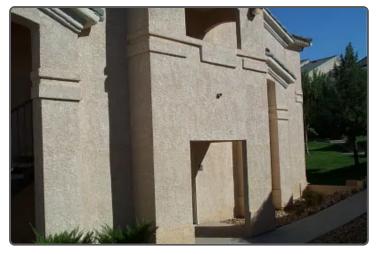
Comp # 201 Stucco Surfaces - Repaint

Painted stucco surfaces are generally in good to fair condition. Some staining and discoloration noted in local areas. Stucco surfaces should typically be repainted approximately every 10 to 12 years to protect stucco surface and maintain appearance. Remaining life based on current condition.

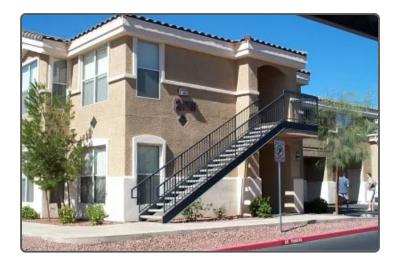
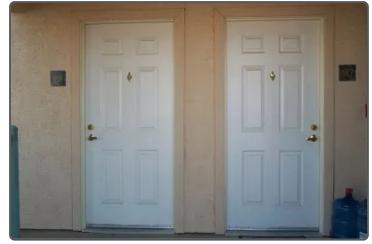
202 Comp# **Building Trim - Repaint**

This component includes the railing, doors, fascia board and any other painted surfaces besides the stucco. Repaint these surfaces approximately every 4 to 6 years to maintain appearance and protect wood and other surfaces. Remaining life based on current age and condition.

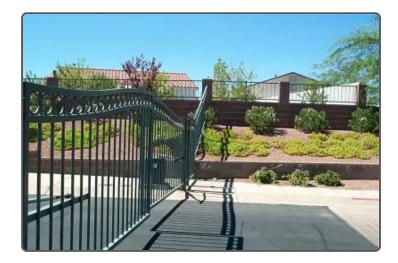
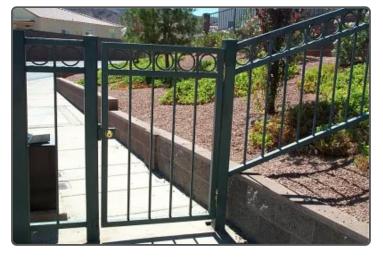
Comp # 206 Vehicle Gates - Repaint

Painted gate surfaces are in good condition. No significant paint loss or appearance concerns noted. We recommend funding to repaint these gates approximately every 3 to 5 years. Remaining life based on current condition.

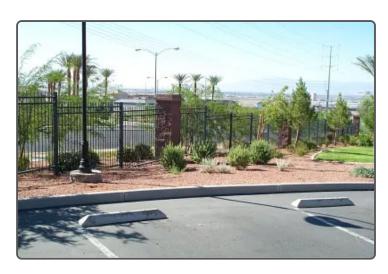
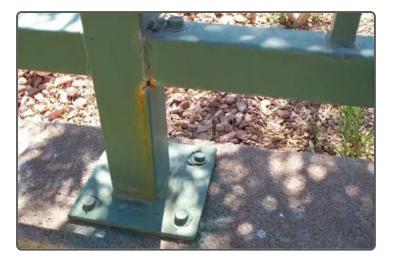
Comp # 207 Wrought Iron Fencing - Repaint

Minor surface rusting noted in local areas. No significant deterioration or broken welds noted. Touch-up problem areas immediately as an operating issue and repaint all fencing approximately every 5 years to ensure full useful life from this component. Remaining life based on current condition.

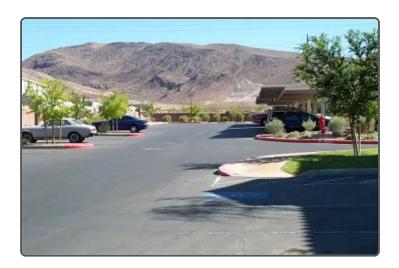
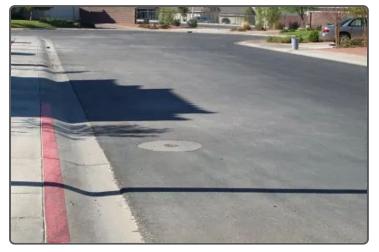
Comp # 401 Asphalt - Major Rehab.

No problems noted at the time of site visit. With regular sealing and repairs (see Comp# 402 Asphalt - Preventive Maintenance) asphalt surface should reach a typical useful life of approximately 30 years before a major rehabilitation (overlay, R & R, etc.) is necessary.

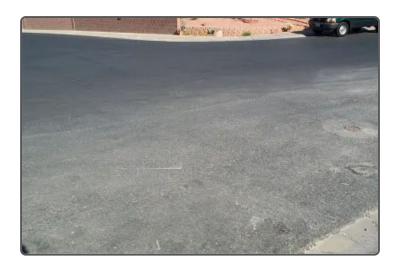
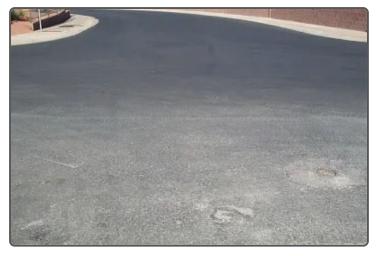
Comp # 402 Asphalt - Preventative Maintenance

Asphalt seal coat is in fair to poor condition. Minor deterioration and loss of seal noted in local areas throughout. Asphalt surfaces should be sealed approximately every 5 years to prevent damage to asphalt surface and ensure full asphalt life. Seal asphalt surfaces this year based on age and current condition.

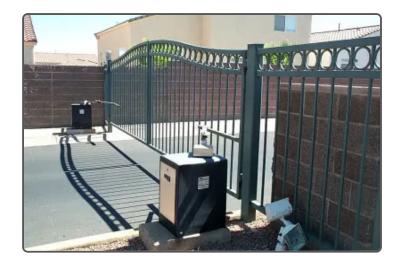
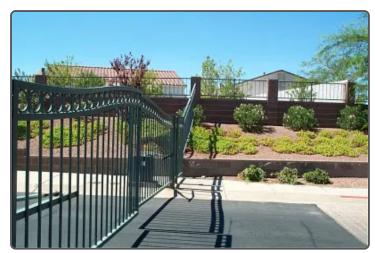
Comp # 504 Vehicle Gates - Replace

Although these gates may reach an extended life we recommend funding to completely replace them approximately every 30 years to ensure appearance and function. We have included funding for the replacement of the adjacent pedestrian gates and fencing at the same time.

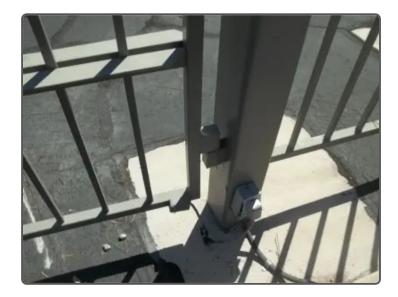
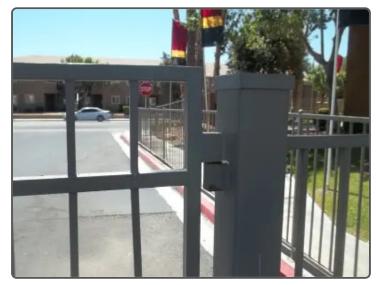
Comp # 505 Vehicle Gate Hinges - Replace

Although vehicle gates may reach an extended life the hinges will need to be periodically replaced to ensure proper function.

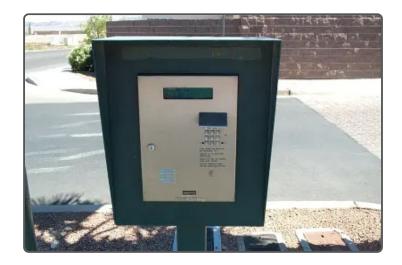
Comp # 506 Phone Entry System - Replace

No problems noted at the time of inspection. System was observed to be functioning normally. This type of system has a typical life expectancy of approximately 10 to 12 years. Remaining life based on current age and condition.

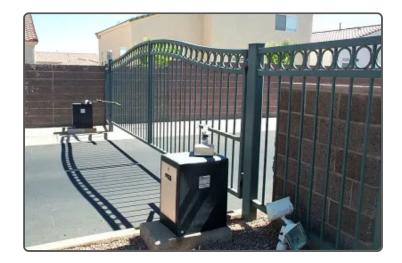
Comp # 507 Vehicle Gate Operators - Replace

No problems noted or reported. Expect a typical useful life of approximately 10 years from these operators. Remaining life based on current age.

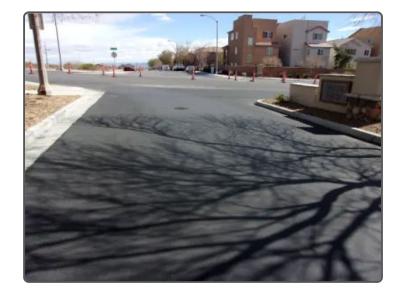
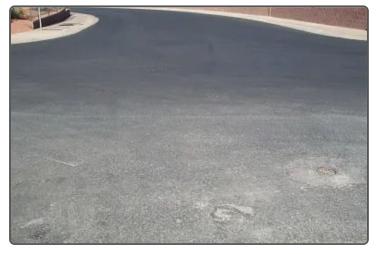
Comp # 508 Gate Loops - Replace

We recommend funding to replace gate loops approximately every 12 to 15 years to ensure proper function.

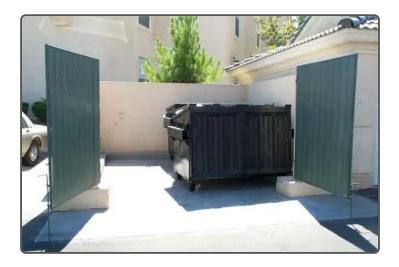
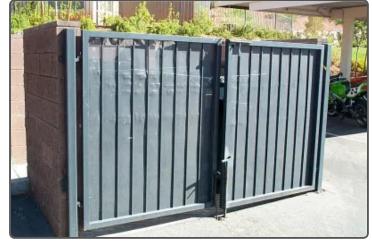
Comp # 590 Trash Enclosure Gates - Replace

We recommend funding to replace the trash enclosure gates approximately every 15 years depending on use and wear. Remaining life based on current condition.

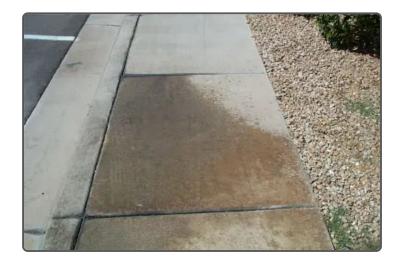
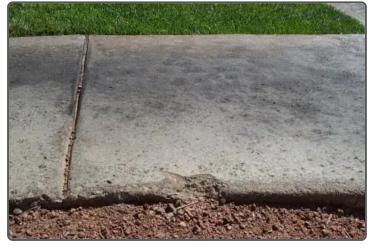
Comp # 601 Concrete Surfaces - Repair

Concrete walks are in good condition. No significant cracking or settling noted. Although concrete is not typically life limited, periodic repairs will be necessary to fix local cracking and settling.

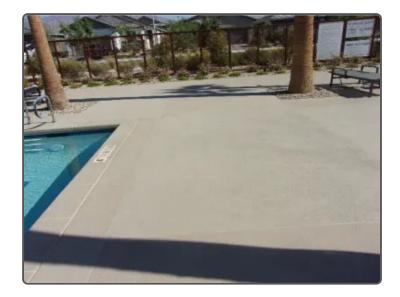
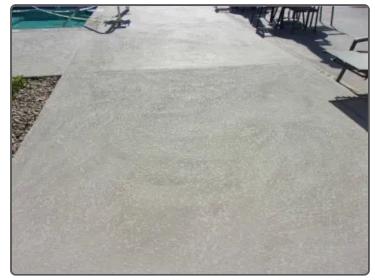
Comp # 603 Pool Deck - Reseal / Repair

Decks are in good condition. Seal these decks approximately every 5 years to protect deck surface and prevent premature deck resurface (see Comp# 604 Pool Deck - Resurface).

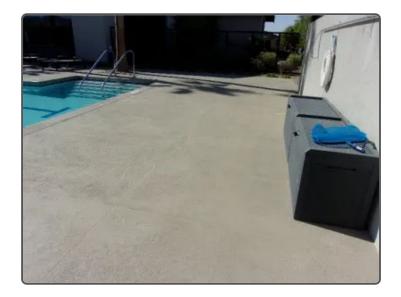
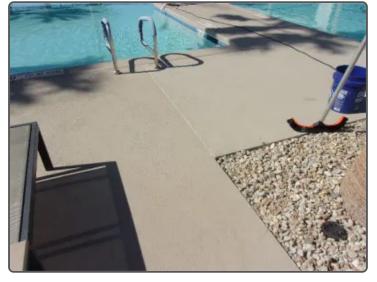
Comp # 604 Pool Deck - Resurface

Deck is in good condition. Expect to seal this component approximately every 5 years (see Comp# 603 Pool Deck - Reseal) and to completely resurface approximately every 20 years.

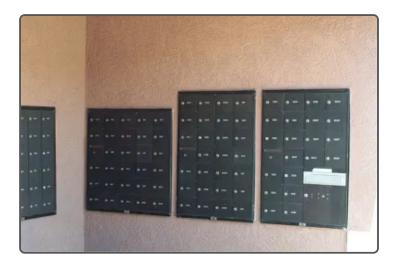
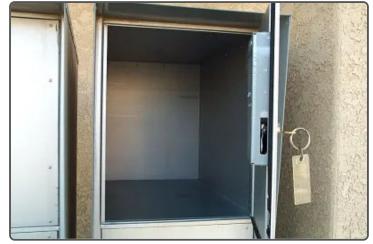
Comp # 803 Mailboxes - Replace

Mailboxes are generally in good condition. No rust or deterioration noted, no broken doors or hinges observed. Boxes are covered and well protected from the elements. Expect these mailboxes to reach a full useful life of approximately 15 to 20 years.

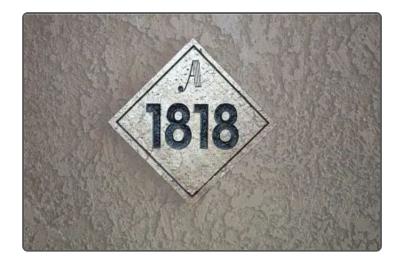
Comp # 805 Building Signs - Replace

Signs are in fair condition. No significant appearance or legibility concerns noted. Expect a typical useful life of approximately 15 to 20 years from these signs. Remaining life based on current condition.

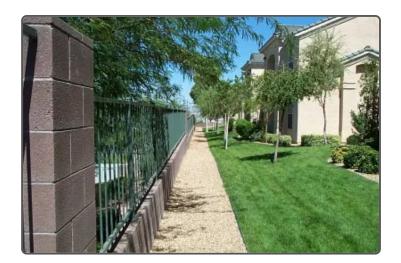
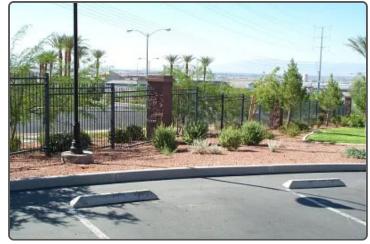
Fencing is in good condition. No significant rusting or structural problems noted at the time of site visit. With regular painting and maintenance, expect a useful life of 20 to 25 years from this component. Remaining life based on current age. 1

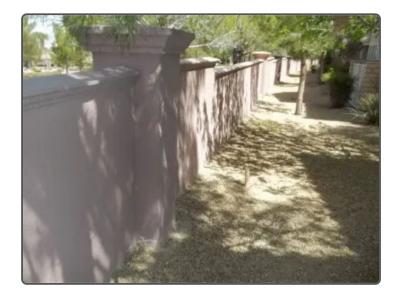
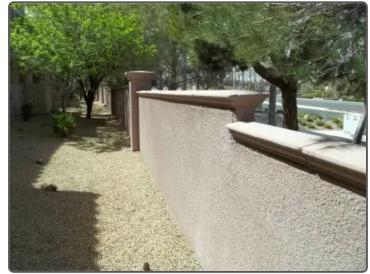
Comp # 1005 Block/Stucco Wall - Repair

No expectation to completely replace walls. Expect to make local repairs as necessary as an operating expense and funding for an allowance to make more significant repairs approximately every 20 years.

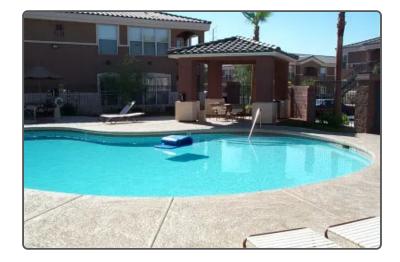
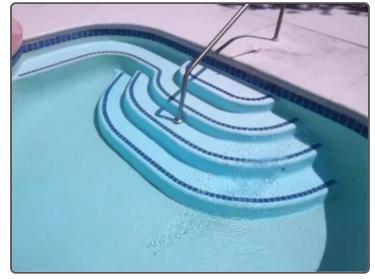
Comp # 1101 Pool - Resurface

Pool is generally in good to fair condition. Pool is approximately five years old. No significant cracking or surface loss noted. Pool plaster has a typical useful life of approximately 10 to 12 years assuming regular maintenance and normal wear.

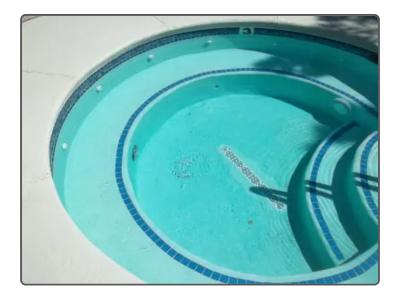
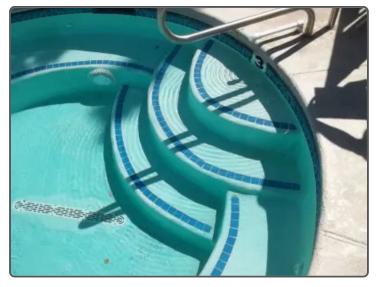
Comp # 1102 Spa - Resurface

Spa is in poor condition. Significant discoloration and surface loss noted at the time of site visit. With regular, professional maintenance expect a useful life of approximately 5 to 6 years from this component. Remaining life based on current condition.

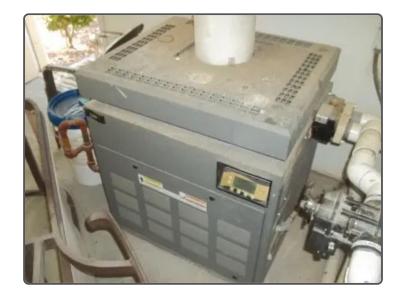
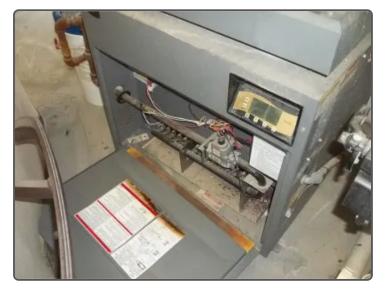
Comp # 1104 Pool Heater - Replace

Pool heater is in older but in good condition. No significant carbon build-up or rust noted at inside base of unit. This type of pool heater typically has a useful life of approximately 10 to 12 years. Remaining life based on current age and condition.

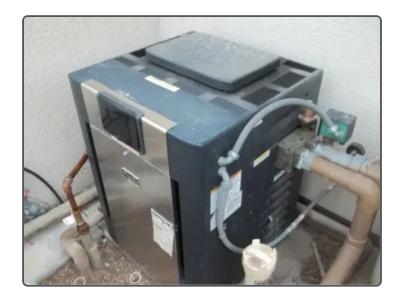
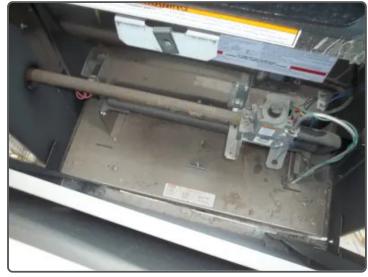
Comp # 1105 Spa Heater - Replace

Spa heater is in good condition. No problems noted at the time of inspection. Because spa heaters have to maintain a higher water temperature they typically have a shorter life expectancy. We recommend funding to replace this heater approximately every 8 years.

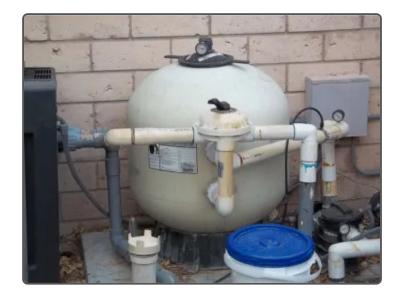
Comp # 1107 Pool Filter - Replace

Pool filter is in good to fair condition. No problems noted at the time of inspection. This type of pool filter has a life expectancy of approximately 12 years. Remaining life based on current age and condition.

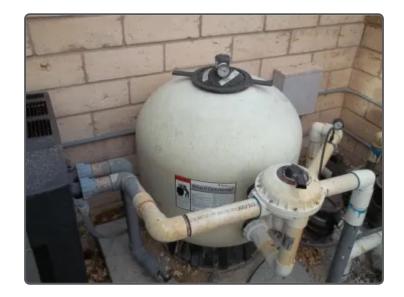
Comp # 1108 Spa Filter - Replace

Spa filter is in good condition. No evidence of significant leaks noted at the time of inspection. With regular maintenance expect a useful life of approximately 10 to 12 years from this component.

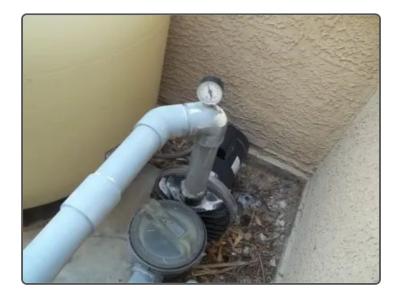
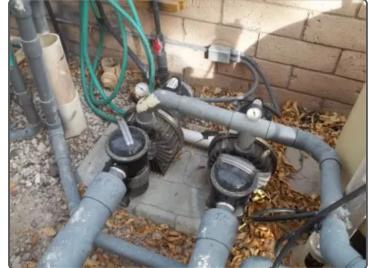
Comp # 1110 Pool/Spa Pumps - Partial Replace

Pumps are in good condition. No expectation to replace all pumps at one time. We recommend funding to replace one pump approximately every three years. Replace motors as necessary as an operating expense.

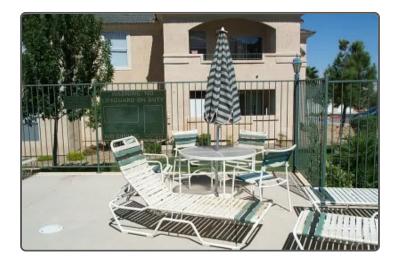
Comp # 1120 Pool Furniture - Replace

Pool furniture is in fair to poor condition. Noted minor sun damage but no broken straps observed. We recommend funding to replace this furniture approximately every 4 to 6 years. We recommend replacing this furniture in the next 12 months based on current condition.

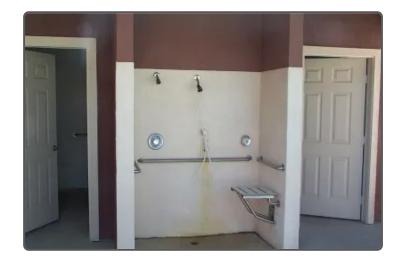
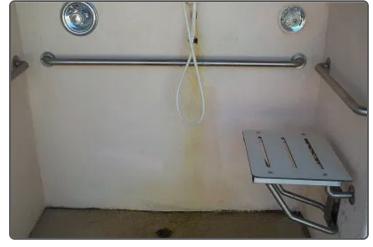
No broken or missing tiles noted, no grout problems observed. We recommend funding to re-tile this shower approximately every 15 to 20 years to ensure appearance and function.

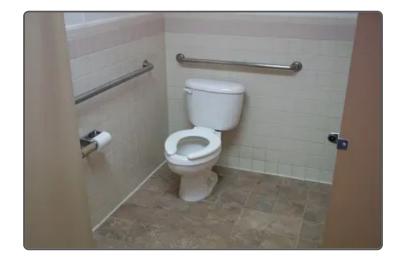
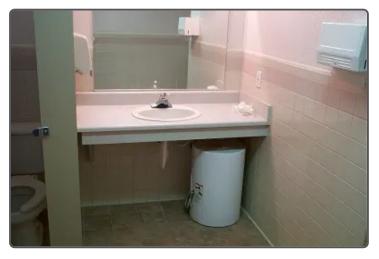
Comp # 1413 Restrooms - Remodel

Restrooms are in good condition. No appearance concerns noted at the time of inspection. We recommend funding to generally remodel and refurbish these restrooms approximately every 15 to 20 years to maintain appearance and keep up with current decorative tastes.

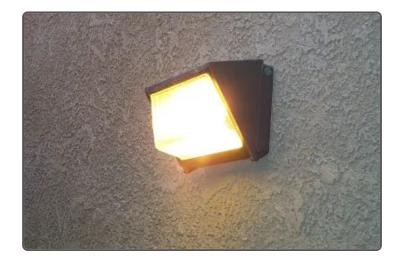
Comp # 1602 Exterior Wall Mount Lights - Replace

Lights are generally in good condition. No significant pitting or discoloration noted. Expect to replace these lights approximately every 16 years to maintain appearance. Remaining life based on current age and condition.

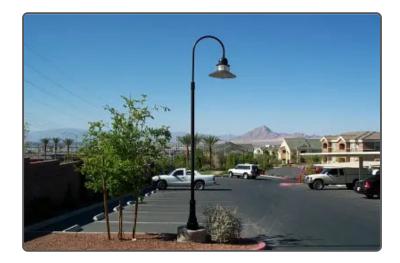
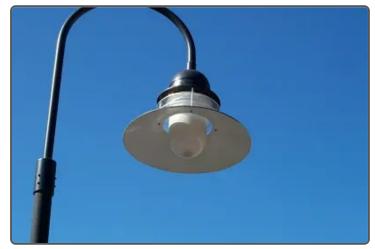
Globes are in fair condition. Due to minimal replacement cost, replace plastic globes as necessary as an operating expense. Light poles have an extended life, no expectation to replace poles. No reserve funding necessary.

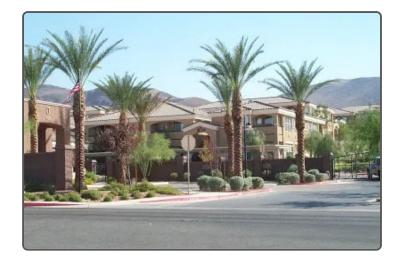
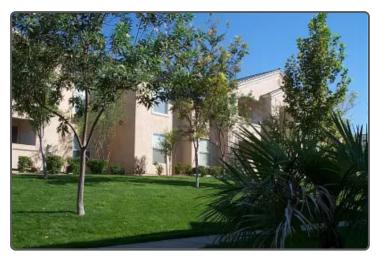
Comp # 1813 Landscaping / Irrigation - Major Renovate

We recommend funding for an allowance for a major project to the landscaping infrastructure including significant and/or total irrigation replacement approximately every 20 years. This allowance should be re-evaluated in future Reserve Studies as the community ages and the property develops a history of repairs, landscaping upgrades, etc.

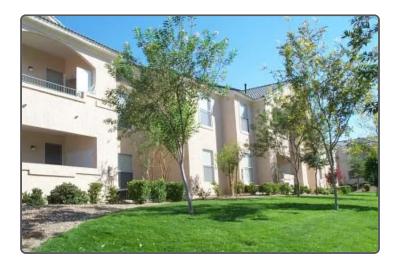
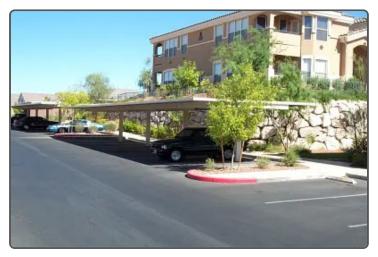
Comp # 1814 Landscaping / Irrigation - Minor Renovate

No expectation to completely re-landscape the community. We recommend funding for an allowance to make repairs to the irrigation system, landscape lighting, and to generally renovate the landscaping approximately every 5 years.
